Fractographic Analysis of the Low Energy
Fracture of an Aluminum Alloy
by

J. Tanaka, C. A. Pampillo and J. R. Low, Jr.

Metallurgy & Materials Science
Carnegie-Mellon University
Pittsburgh, Pennsylvania 15213

NASA Technical Report No. 1

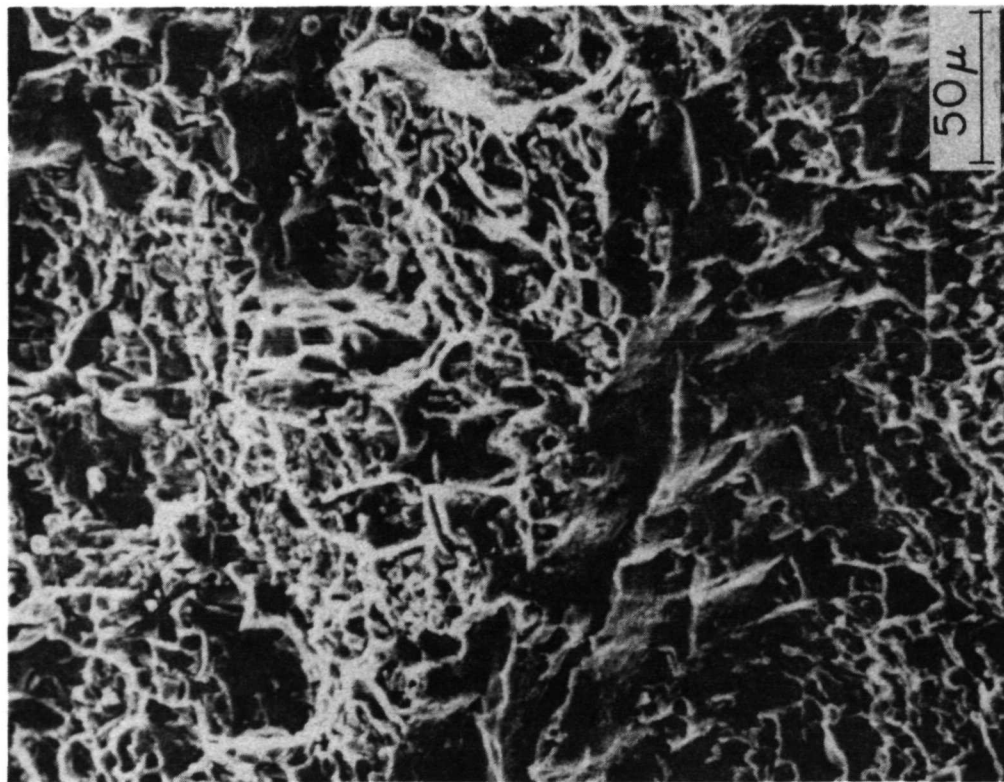
Fig. 7 Low Magnification Scanning Electron Micrograph Taken with Secondary Electrons, to Compare with Back Scattered Electrons in Fig. 8

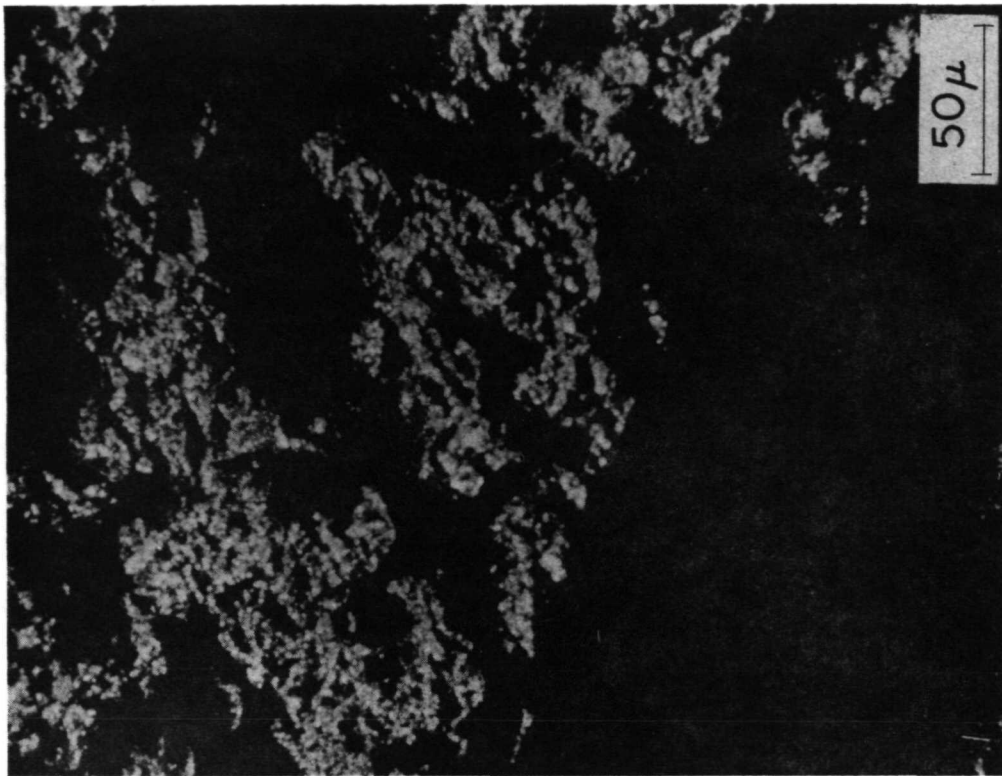
Fig. 8 Same as Fig. 7 Taken with Back Scattered Electrons

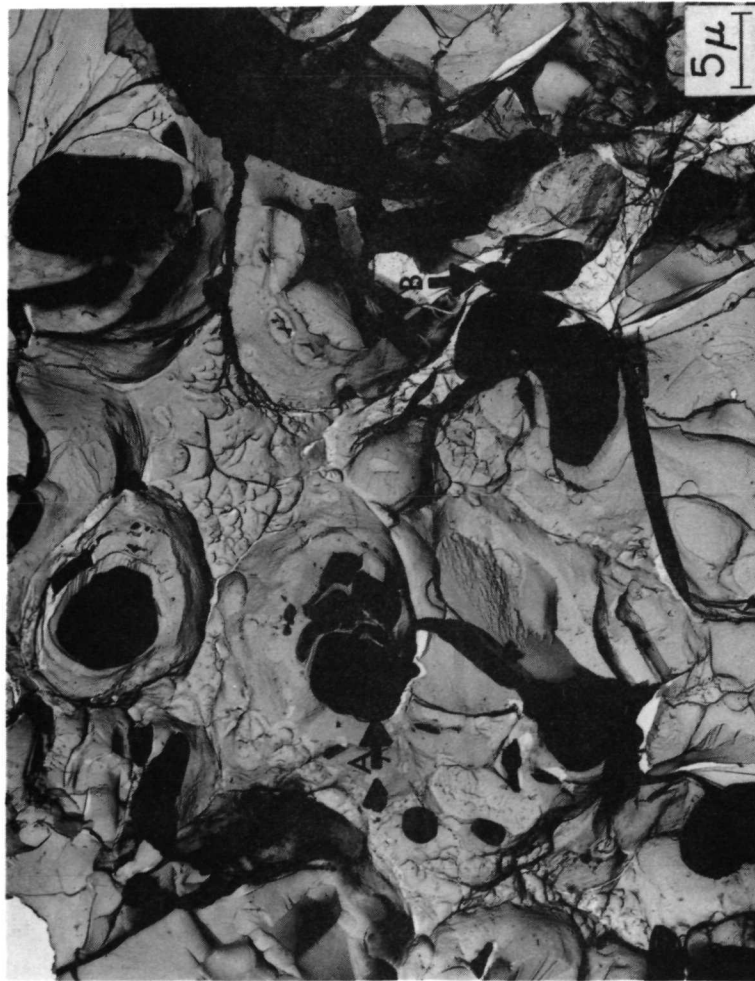
electron micrographs of typical extraction replicas. Many particles were extracted and seem to remain in the place corresponding to the dimple they had originated. However, some were found moved from their original position. The micro probe showed that the particles contained Cu, Si and Al, and some only Si, Figure 21. Comparing these results with those of the polished samples, it seems that either the particles containing Fe, Si and Mn were not extracted from the fracture surface or that they do not contribute to the formation of dimples. Direct micro probe analysis of the fracture surface with the micro probe, which detected the inclusions which contained Fe, and the fact that no special type of inclusions was found not to crack in the deformed samples seems to indicate that the inclusions were not extracted from the fracture surface.

Fig. 20 Electron Microscope Micrograph of an Extraction Replica

Figures 22a and b shows diffraction patterns for the particles A and B shown in Figure 20 and in the micro probe micrograph in Figure 21. An analysis of the diffraction patterns obtained of the particles in the extraction replicas might correspond to Al_4Cu_9 or $\text{Cu}_{15}\text{Si}_4$ and pure Si or Cu_5Si or CuAl_2 .

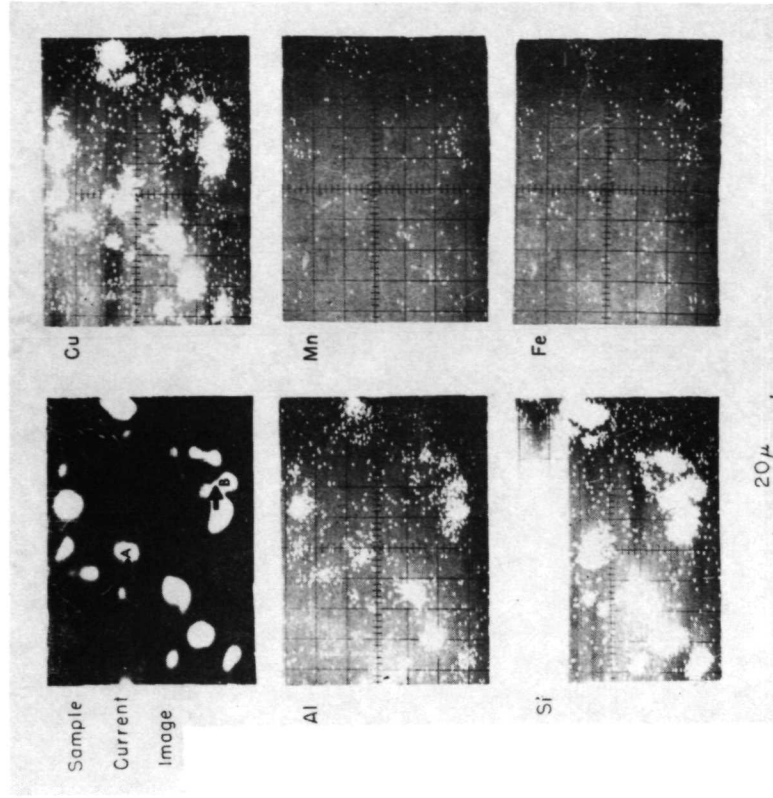
Fig. 21 Electron Micro Probe Analysis of Particles in Extraction Replica Shown in Fig. 20

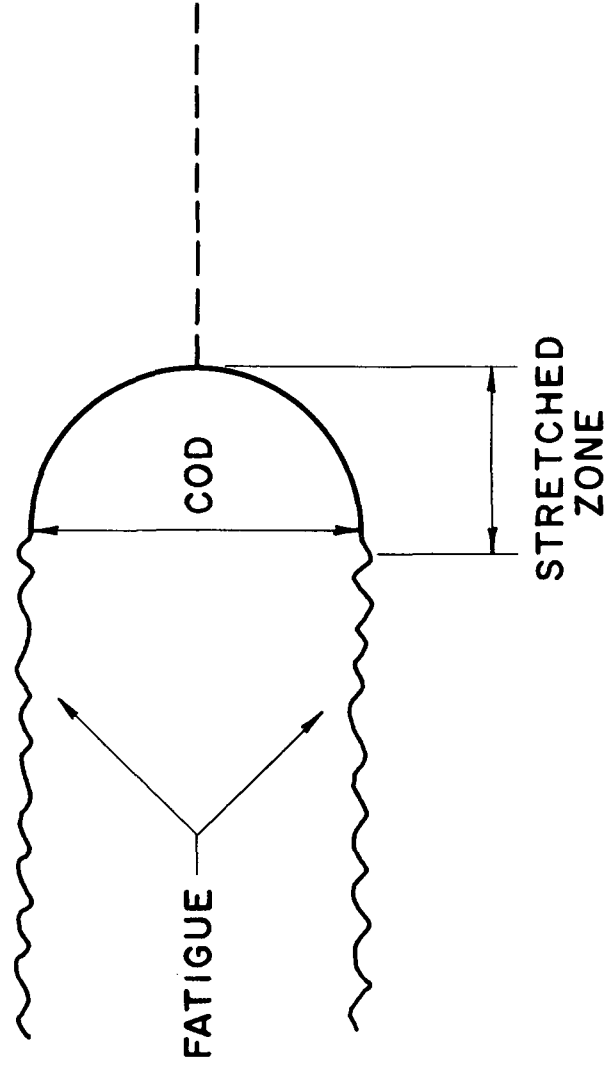
The formation of the stretched zone must involve some complex slip mechanism at the crack tip. We would like to suggest here that this mechanism should be similar to that proposed by Rogers⁽¹²⁾ to explain the formation of lips of a ductile copper tensile specimen that failed in a double cup fashion. The mechanism has been called "ductile cutting." Two factors, which we believe are also involved in the formation of the stretched zone are large amounts of plastic deformation necessary to provide the separation or "cutting" of the material and low triaxiality to inhibit void growth during its formation.

Fig. 26 Sketch Showing Blunting of the Crack Tip and the Stretched Zone
